**Maryland Historical Trust
State Historic Sites Inventory Form**

Survey No. CARR-1455

historic George Croft Farm

and/or common Camp Shiloh

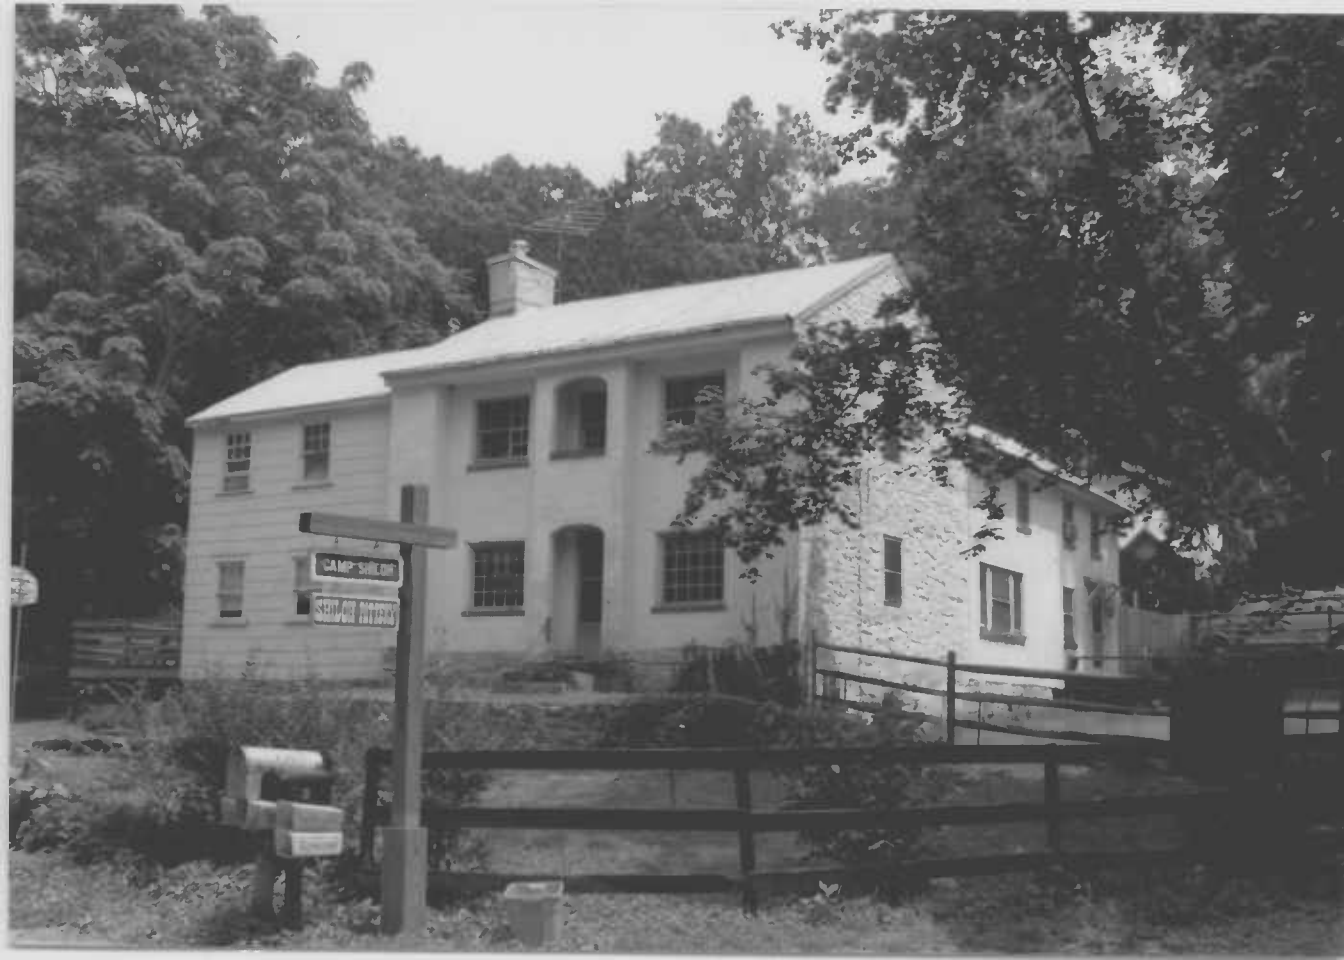
1/5

Neg. loc.: Maryland Historical Trust
house-NW: SW elevs.

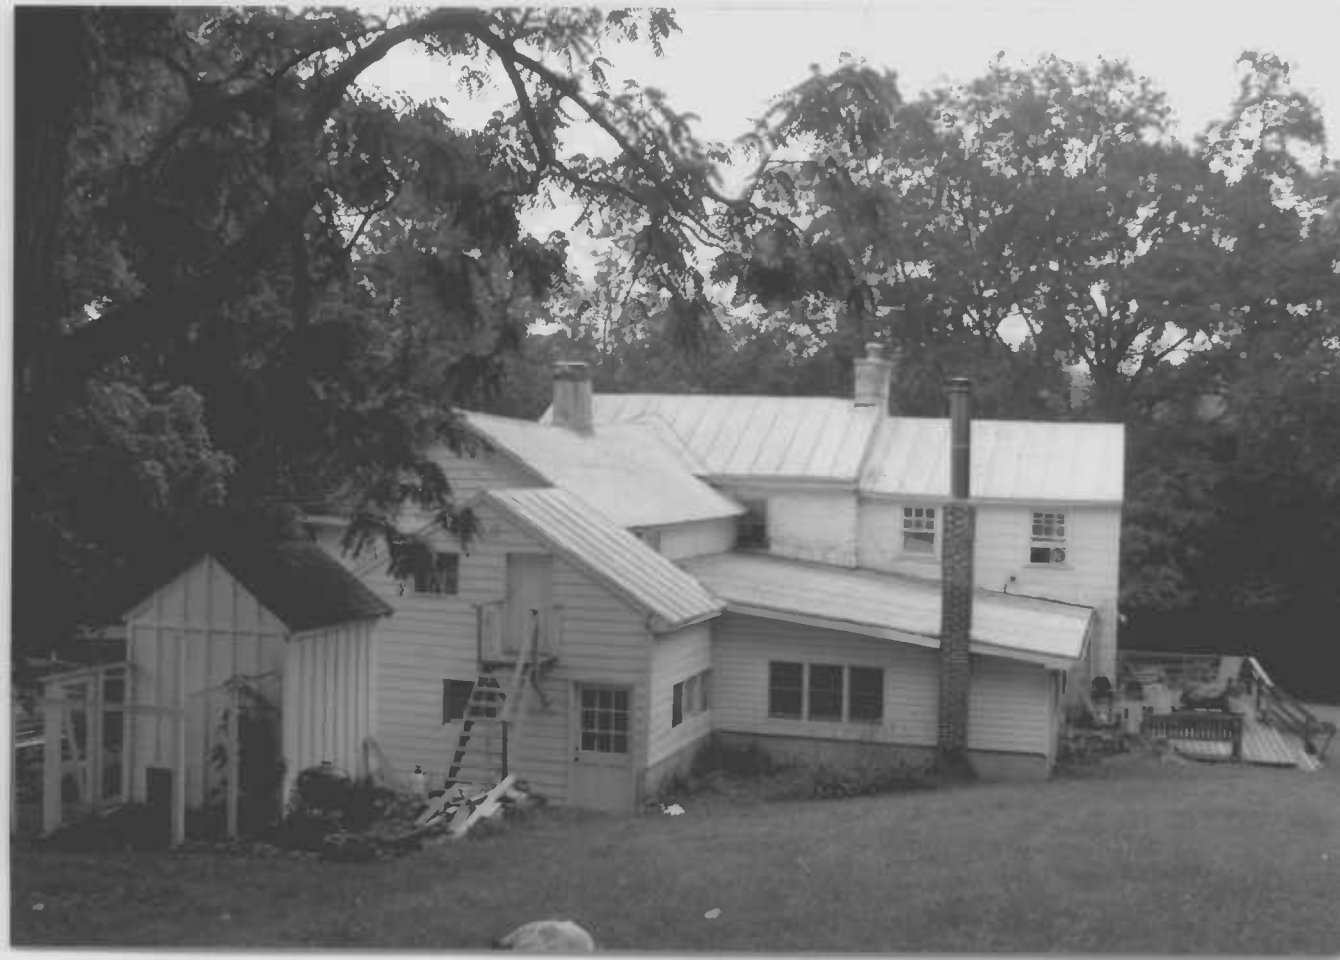
George Croft Farm
1027 Brodbeck Rd.
Carroll County, Maryland
Photo: Matt Hankins
Date: July 1995
Neg. Loc.: Maryland Historical Trust
house - SE ; NE elevs.
2/5

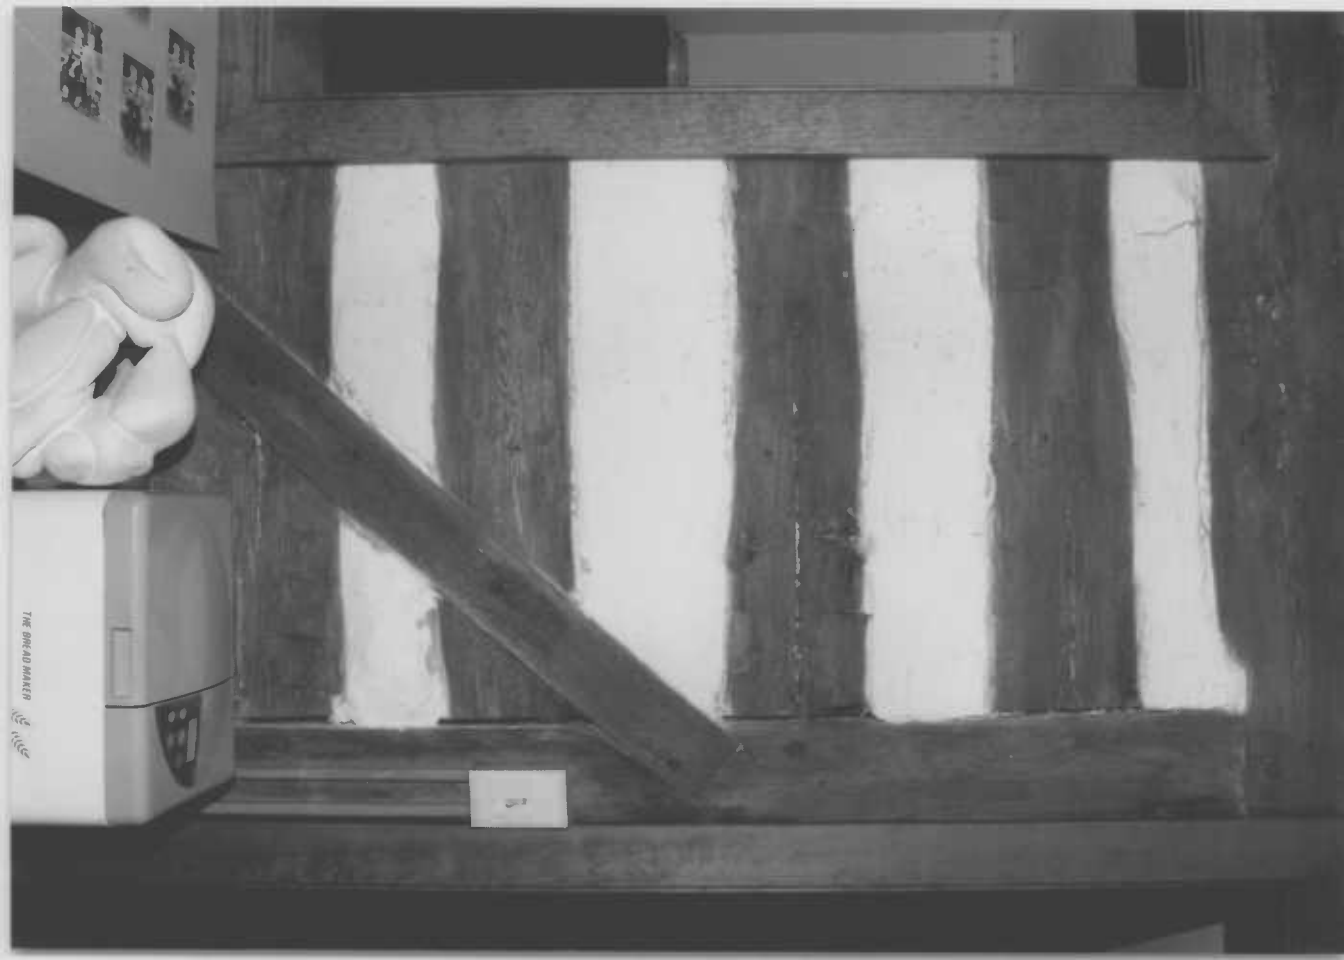
3/5

Neg. Loc.: Maryland Historical
log detail on NE

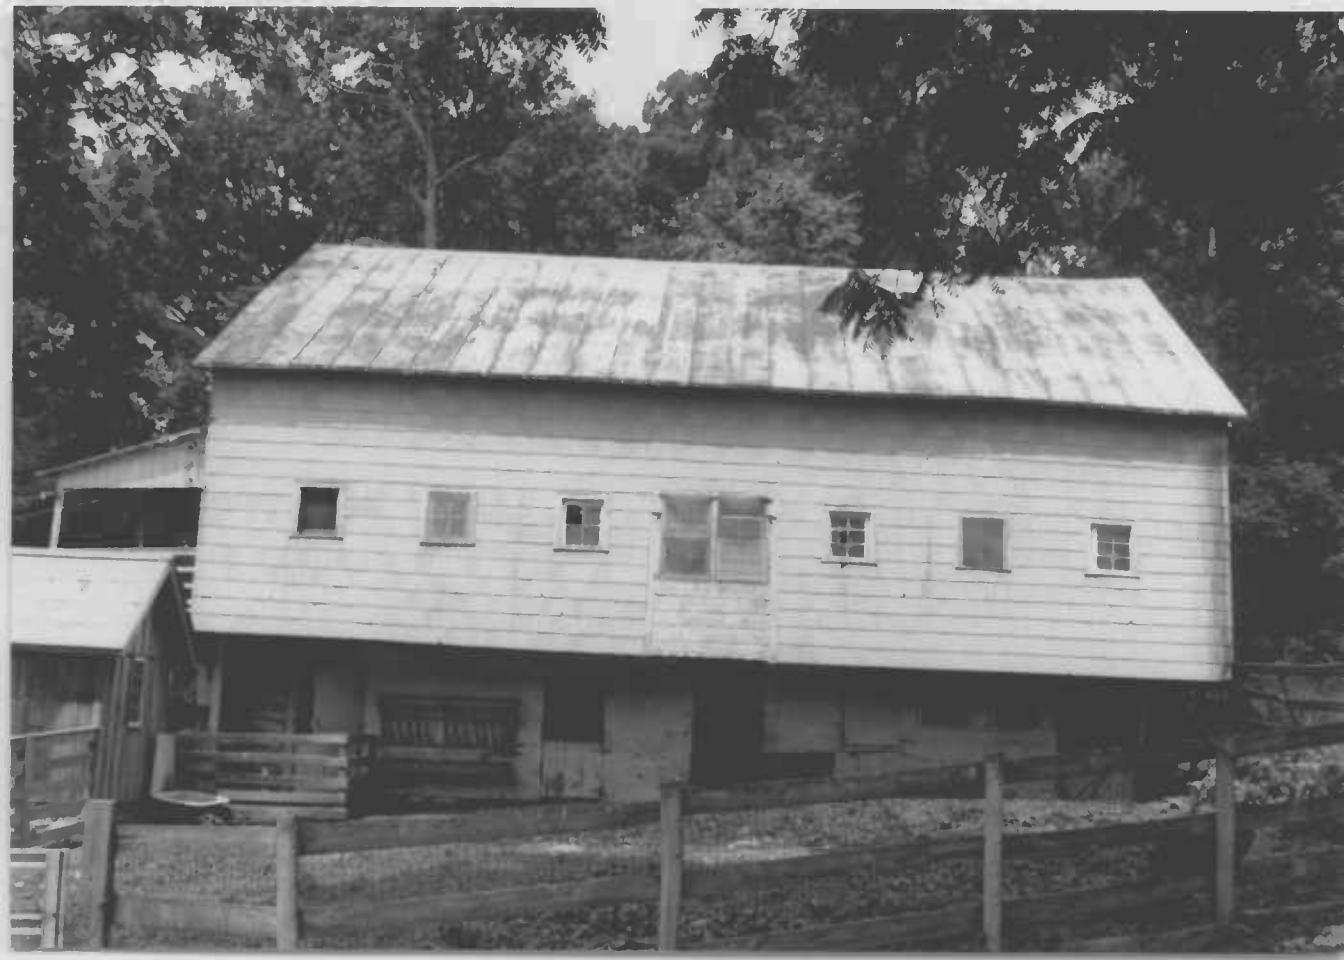
4/5

There is a bank barn about 60 feet southeast of the shed. It has a rubble stone lower story with vertical boards on the lower story forebay wall. The upper story has asbestos shingles on the northwest and southwest elevations, some board and batten on the northwest elevation, asphalt shingles on the southeast elevation, and board and batten on the northeast elevation. It has a gable roof of standing-seam metal with a northwest to southeast ridge. The forebay of the barn faces southwest. The lower story of the southwest elevation has four vertical-board dutch doors to the west, then two window openings, and another dutch door in the south bay. The upper story has a center double-door opening that has been converted to two 6/6 sash. There are three small window openings on either side. The southeast elevation has a wide opening on the upper story and two window openings in the lower story. The northwest elevation has a porch added to it, and the porch has been infilled to the north. Above the porch roof is painted "CAMP [SH]ILOH." The northeast elevation has a shed-roof addition over the wagon doors with a louver vent both to the north and east of these doors. The lower story has two hewn summer beams with four posts under each, and with splayed half-lap scarfs. The joists are all one piece and are hewn on top and bottom inside the barn and on all four sides under the forebay. The stall arrangement has been altered. The upper story has been altered for use by the camp. It has three bays with a center threshing floor and one mow on each side. There are four hewn bents that are mortised and tenoned and pegged, with Queen post trusses supporting the roof. The rafters are ¾-round logs with a ridge pole.

George Croft Farm
1027 Brodbeck Rd.
Carroll County, Maryland
Photo: Matt Hankins
Date: July 1995
Neg. Loc.: Maryland Historical Trust
barn - SW elev.

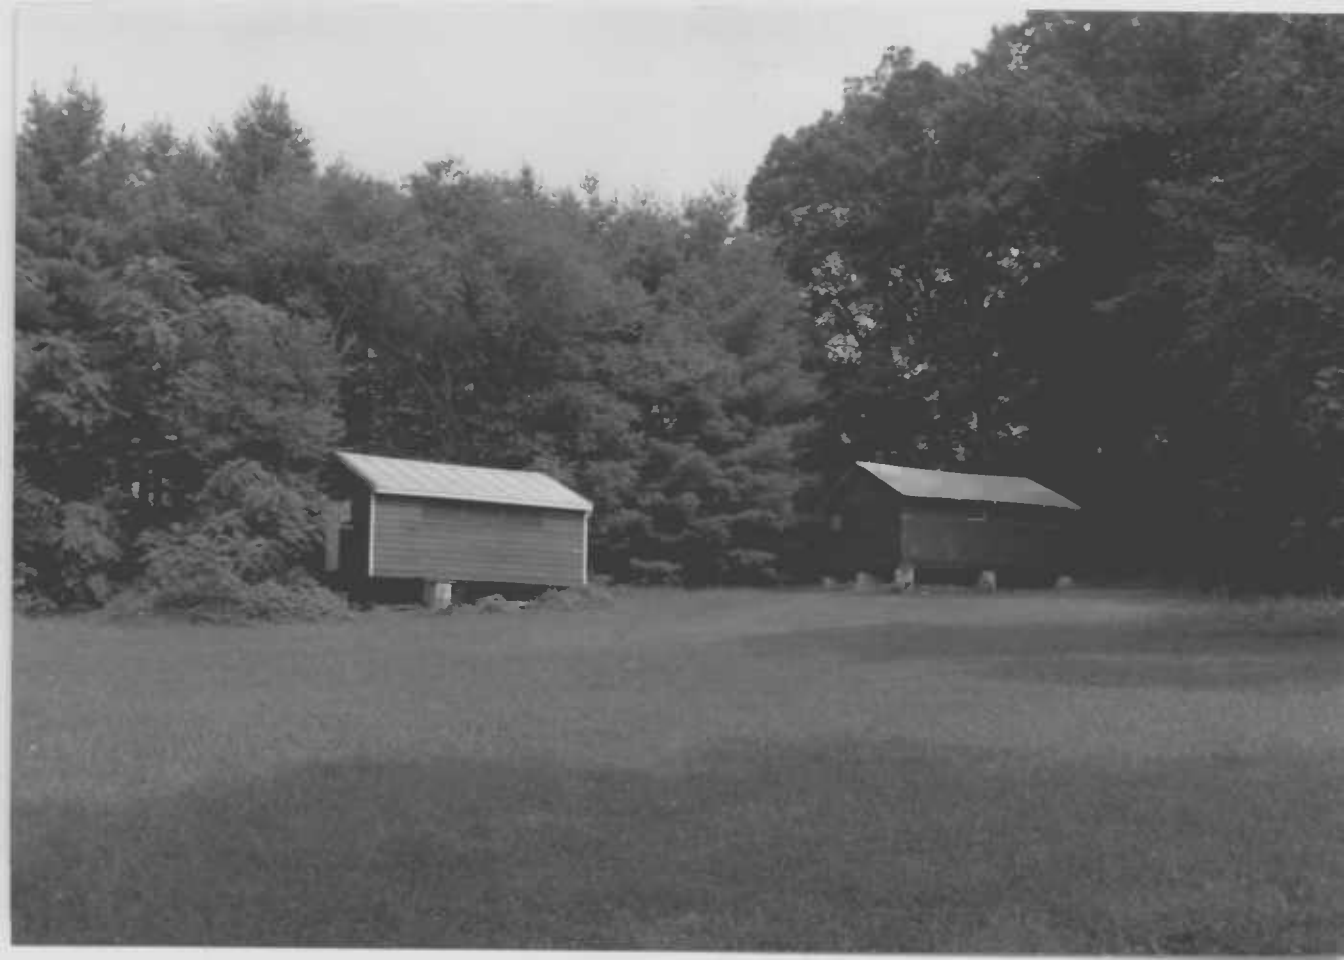
Also on the property are approximately twelve cabins of 2 x 4 construction with either clapboard or German siding. They are one-room buildings with a small bathroom attached to the rear. They each have a gable roof with standing-seam metal and a door on the gable end. Most of these buildings were moved here from other camps, according to the owner.

George Croft Farm
1027 Brodbeck Rd.
Carroll County, Maryland
Photo: Matt Hawkins
Date: July 1995
Neg. Loc.: Maryland Historical Trust
Cabins - NW elevs.
5/5
